Enhancing urban resilience in historical centers: a scenario-based approach to seismic risk and strengthening interventions

Hooman Mehralian¹, Nicola Chieffo²

The proposed study deals with seismic vulnerability assessment and highlights the importance of evaluating urban vulnerability in historic areas. Focusing on Portugal's mainland, the case study area is located within the historical part of the Lisbon city council. The main objective of the proposed research is to evaluate the seismic vulnerability of existing unreinforced masonry residential buildings, given their prevalent nature and sensitivity to earthquake damage. This study, by providing an example of an urban-scale assessment approach, offers an overview of potential strengthening solutions and proactive risk-reduction measures in seismically-prone areas. To gather comprehensive information on the problem, a methodology was developed including site inspections integrated with remote sensing data. This combined approach highlighted the importance of conducting remote sensing with careful consideration and input from experts in building characteristics. Urban renovation works in historical centers often preserve archite

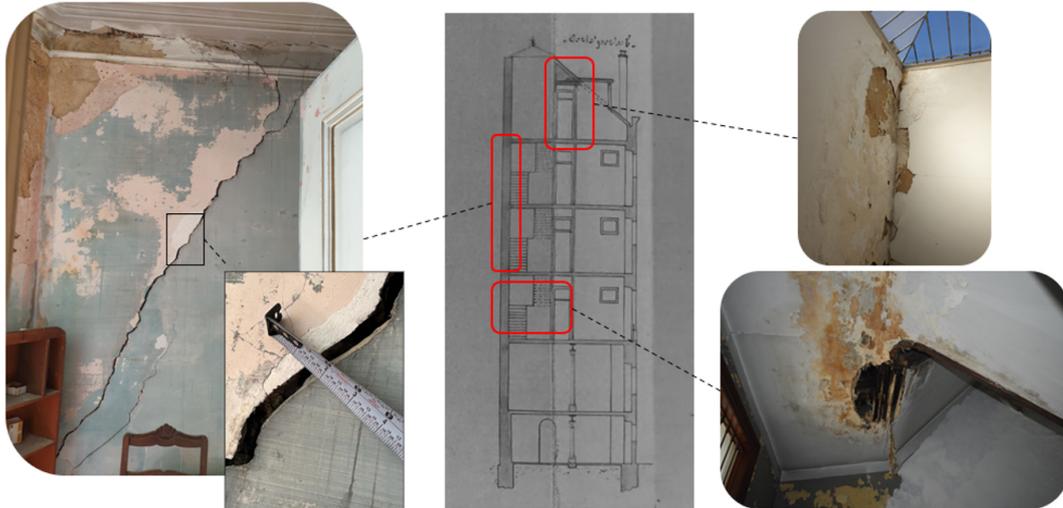
Figure 5. On-site inspection: deterioration of an example building.

However, following certain events, increased levels of damage have been observed, rendering the upper floors unsafe for human occupancy. Wooden floors have been particularly affected by issues such as dry rot and water damage. The weaknesses in these floor systems pose a significant risk, which is exacerbated by events such as earthquakes that can further deteriorate the damage. The challenges in the structure are further complicated by the presence of dry rot and water damage on wooden floors. If these issues are not promptly addressed, they not only compromise the safety of occupants but also necessitate extensive repairs to restore the structural integrity of the building. To illustrate these concerns, Figures 5 and 6 provide visual examples, highlighting the urgent need for thorough assessments and targeted interventions to address the current conditions of floors and other critical components. For example, in Figure 5, seams and cracks were

observed in the walls, which were as large as 3-5 cm, indicating significant structural distress. These fissures not only compromise the aesthetic integrity of the building but also serve as critical indicators of underlying issues that may affect overall stability. Furthermore, water leakage was noted, penetrating the walls and leading to decay in the surrounding materials. This decay not only weakens the structural components but also creates a conducive environment for mold growth, which poses health risks to occupants. The cumulative effect of these damages ultimately resulted in the collapse and destruction of key elements of the main structure.

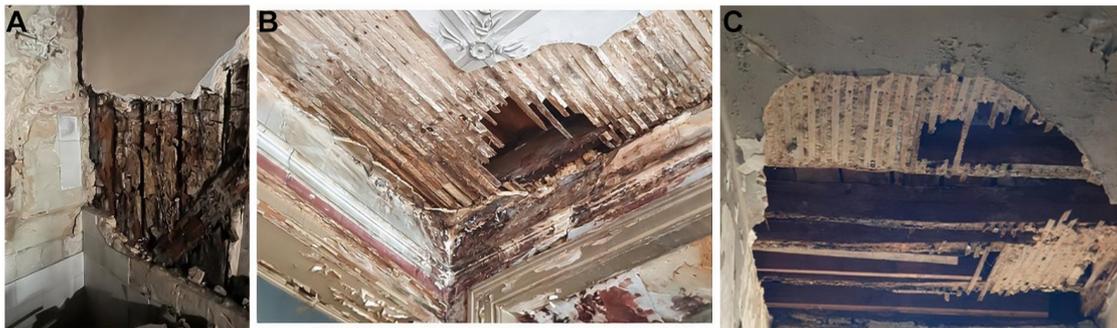
Figure 6. Severe situations and deteriorated parts: Interior wall (A), roof (B), and floor (C).

Figure 6 demonstrates the devastating situation and underscores the need for urgent intervention. The visual representation in this figure, such as rotten wooden walls and ceiling, highlights the severity of the damage, showcasing areas where structural integrity has been compromised, further emphasizing the immediate requirement for thorough assessments and remedial actions.

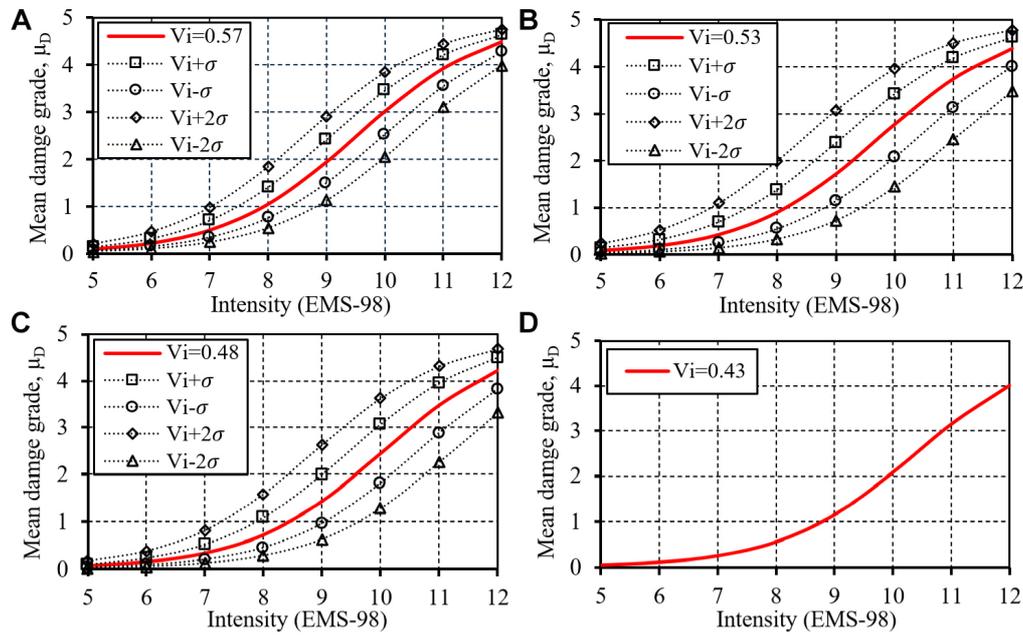
Figure 8. Mean damage curves for typologies: (A) M1; (B) M5; (C) M6; and (D) M7.

The curves are depicted in Figure 8, accounting for the relation between the mean damage grade (μ_D) and MSI based on the EMS-98 damage grades ranging from 0 to 5. Each building typology (M1, M5, M6, M7) is characterized by a specific mean vulnerability index of the building class and standard deviation (σ). Moreover, the curves are plotted considering up to \pm two standard deviations, σ , to statistical-related damage within upper and lower bounds for building stock.

For instance, [Figure 8A](#) illustrates the mean damage grade (μ_D) for the M1 typology, which primarily consists of Rubble Stone buildings and includes some Pre-Pombalino structures, across various intensity levels. This figure also features four additional curves representing \pm two standard deviations. Conversely, in [Figure 8D](#), the M7 typology (Reinforced/Confined Masonry or RCM) lacks standard deviation curves. This is because there is only one building of that typology, resulting in a single graph without the additional standard deviation curves. Moreover, by comparing the mean damage grade (μ_D) calculated in this study with the corresponding one proposed by Oliveira^[53] for Portuguese building typologies (see [Figure 9](#)), it was observed that in the proposed study, the vulnerability indices vary between 0.57 and 0.43 for typologies M1 to M7, respectively, while Oliveira considers the mean values to range from 0.77 to 0.54 for typologies M1 to M7, respectively. Thus, from the obtained results, the proposed approach (red line) provides mean percentage differences of 30% lower than Oliveira’s^[53], which can be attributed to the use of different approaches for calculating the vulnerability parameters for masonry aggregates. Additionally, Oliveira’s proposal may take a more conservative approach, assuming a higher index for the examined buildings.

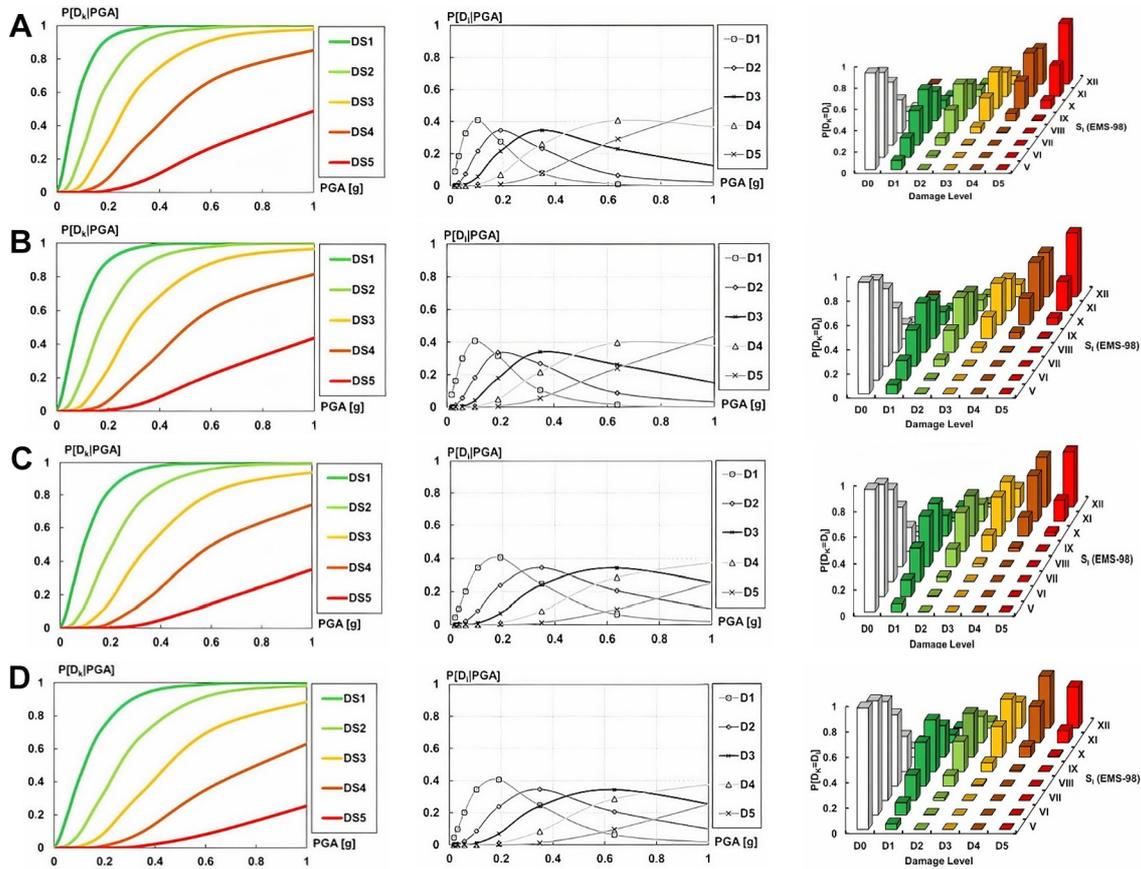
Figure 10. Fragility curves and DPM distribution for examined building typologies. (A) Rubble masonry, $V_{l,mean} = 0.57$; (B) URM with wood floors, $V_{l,mean} = 0.53$; (C) URM with RC floors, $V_{l,mean} = 0.48$; (D) Reinforced/Confined masonry, $V_{l,mean} = 0.43$.

The provided scenario illustrates the relationship between damage grades (D0 to D5) and PGA/intensities for each typology. Notably, for lower intensities, the probability of attaining the lowest damage grade is the highest, while the probability of experiencing the highest damage grade is the lowest. This indicates a lower likelihood of damage occurrence at lower intensities. In the first typology (Rubble Masonry with

$V_{l,mean} = 0.57$) for the intensity of V, the probability of attaining the lowest damage grade, D0, is almost 90%, whereas the probability of D5 is nearly zero.

As a result, fragility curves were developed employing the binomial distribution function, which estimates the likelihood of damage based on the average damage grade, μ_D . Thus, utilizing Equation (7), the cumulative mass function was calculated to derive the fragility functions for the examined masonry typologies within the Lisbon Historical Center and the results are summarized in Figure 10.

Conversely, as intensity levels increase towards XII, the probability of a higher damage grade also grows. For example, again, in the first typology, the probability of attaining D0 in intensity XII is near zero, while that of experiencing the highest damage grade, D5, is 58%. This suggests a higher susceptibility to severe damage or devastation at higher intensity levels. It is important to note that while the D0 curves are not plotted in Figure 10, the probability of no damage (D0) is implicitly represented in the overall distribution of damage states, ensuring a comprehensive understanding of how damage probabilities relate to seismic intensities.
