Enhancing urban resilience in historical centers: a scenario-based approach to seismic risk and strengthening interventions

Keywords: Vulnerability assessment, loss estimation, urban resilience, historical masonry buildings

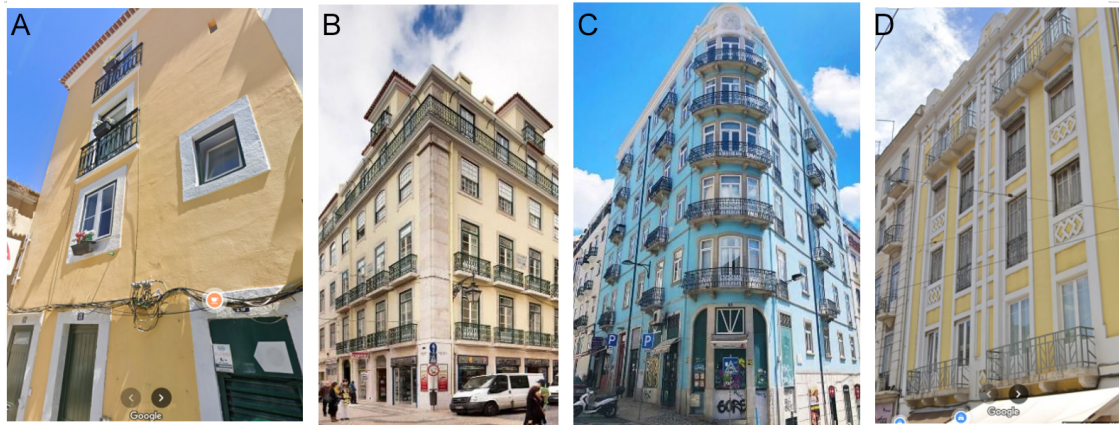
Figure 1. Typology of Portugal's historic masonry buildings: Pre-Pombalino, Pombalino, Gaioleiro, and Placa. It highlights the characteristics and structural features of each typology, emphasizing their historical significance and variations in construction methods.

The city's central buildings are classified into different types, i.e., Pre-Pombalino, Pombalino, Gaioleiro, and Placa [Figure 1]. Pre-Pombalino buildings lacked seismic resistance due to their construction methods and materials. However, after restoration, these structures served various purposes, showcasing their adaptability and functionality. Pombalino buildings, crafted in the aftermath of earthquakes, showcase robustness through the incorporation of "Gaiola Pombalina" walls. These walls ingeniously blend traditional wooden construction techniques with advanced seismic principles, highlighting a design that prioritizes earthquake resistance and structural stability. Gaioleiro buildings in the historic center are designed to match and work well with the natural features of the land. Using timber frames and flexible structures, these buildings adapt to the terrain by adjusting to any shifts or settling in the ground. In essence, they are smartly crafted to fit in harmoniously with their surroundings. Placa buildings incorporate RC frame elements, which, despite being durable and cost-effective, face criticism for their architectural quality. Critics argue that these structures lack aesthetic appeal or distinctive design features, expressing concerns about their visual uniqueness. Despite their proven durability and cost efficiency, the buildings are challenged for not meeting certain standards in terms of architectural creativity and overall attractiveness. Recent efforts aim to renovate and upgrade Placa structures while preserving their architectural heritage in Lisbon^[1,2].

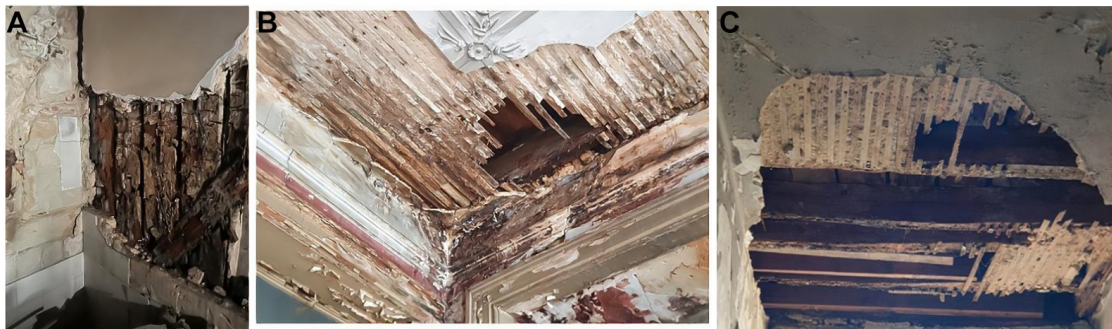
Figure 6. Severe situations and deteriorated parts: Interior wall (A), roof (B), and floor (C).

Figure 6 demonstrates the devastating situation and underscores the need for urgent intervention. The visual representation in this figure, such as rotten wooden walls and ceiling, highlights the severity of the damage, showcasing areas where structural integrity has been compromised, further emphasizing the immediate requirement for thorough assessments and remedial actions.
