Short Communication

Occurrence and identification of microplastics retained in corrosion deposits of drinking water transmission pipes

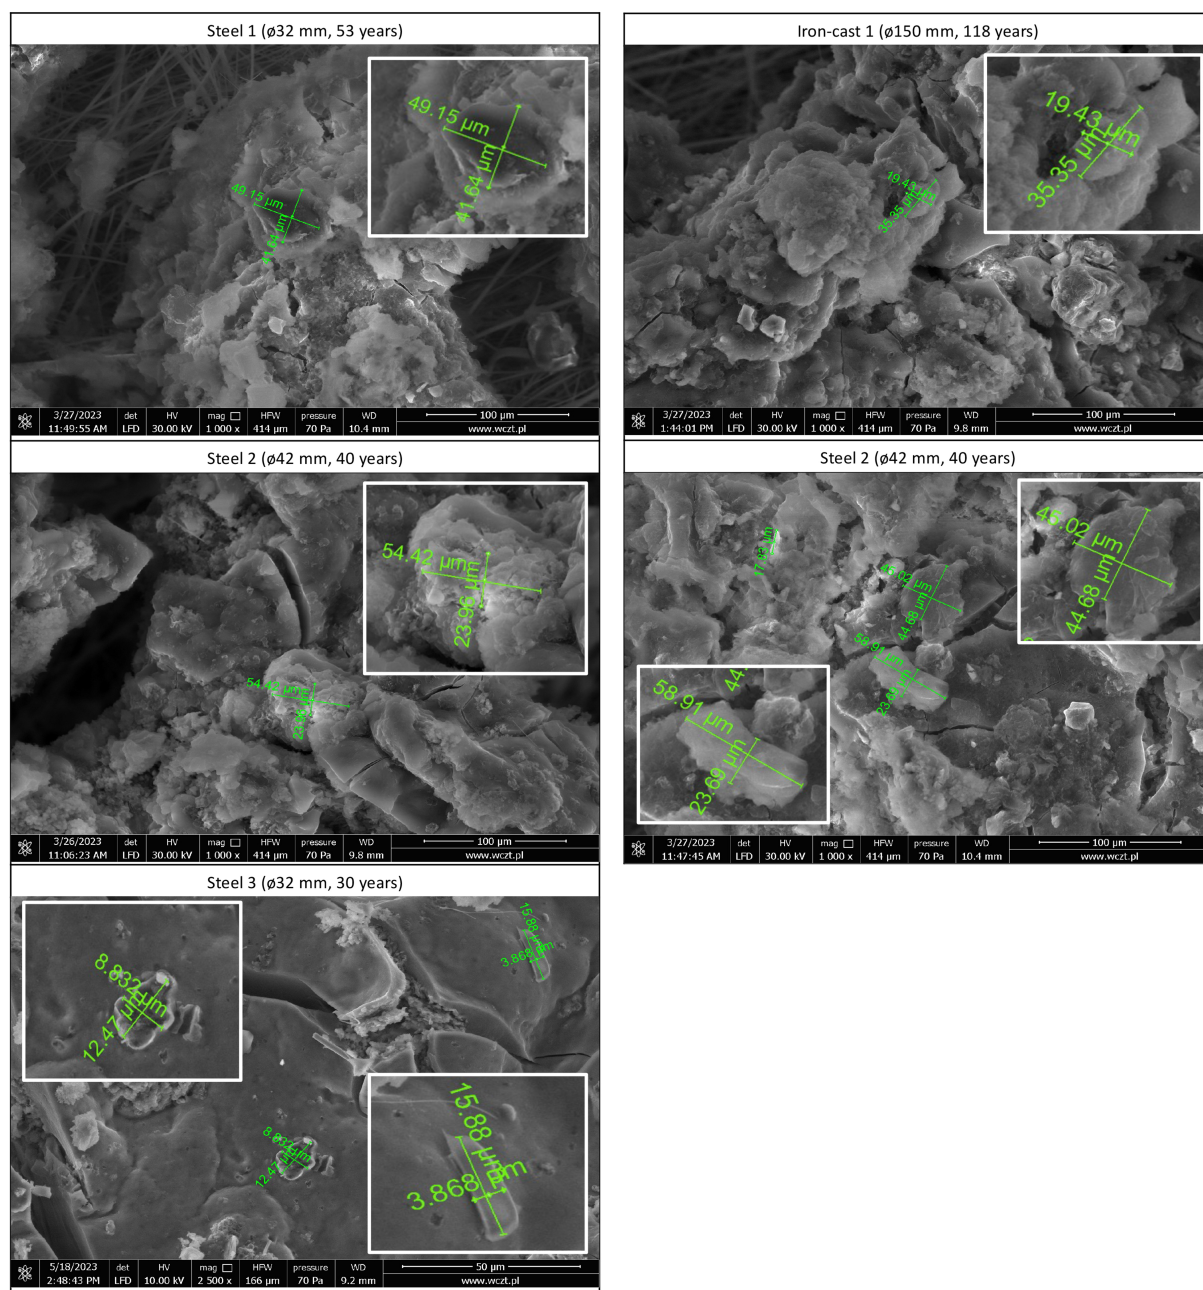
Figure 1. Examples of dimensioned MP particles. MP: Microplastic.

EDS mapping of carbonaceous areas allowed the size distribution of MPs to be determined. Five main size ranges were distinguished: < 50, 50–100, 100–150, 150–200, and > 200 µm [Table 1 and Figure 1]. In all sediments studied, more than 90% were particles < 50 µm. As the size of the particles increases, their content in the sediments decreases. A similar trend was observed in studies for tap water, where particles < 10 µm accounted for the largest percentage among the identified MPs^[33,37]. Only two of the analyzed sediments contained particles > 200 µm, probably originating from the degradation of plastic pipes operating in other areas of the network, which is also confirmed by the reported high removal efficiency (up to 90%) of MPs > 10 µm in water treatment processes^[13,38,39]. In the case of particles in the 50–200 µm range, an uneven distribution has been observed, most likely linked to the different pipe diameters, thickness, porosity, and build-up time of corrosion deposits. In addition, an important aspect influencing the presence of larger size fractions in the sediments is the remoteness of the intake site from the treatment plant, as plastic water pipes can be a source of secondary contamination of drinking water with MPs.

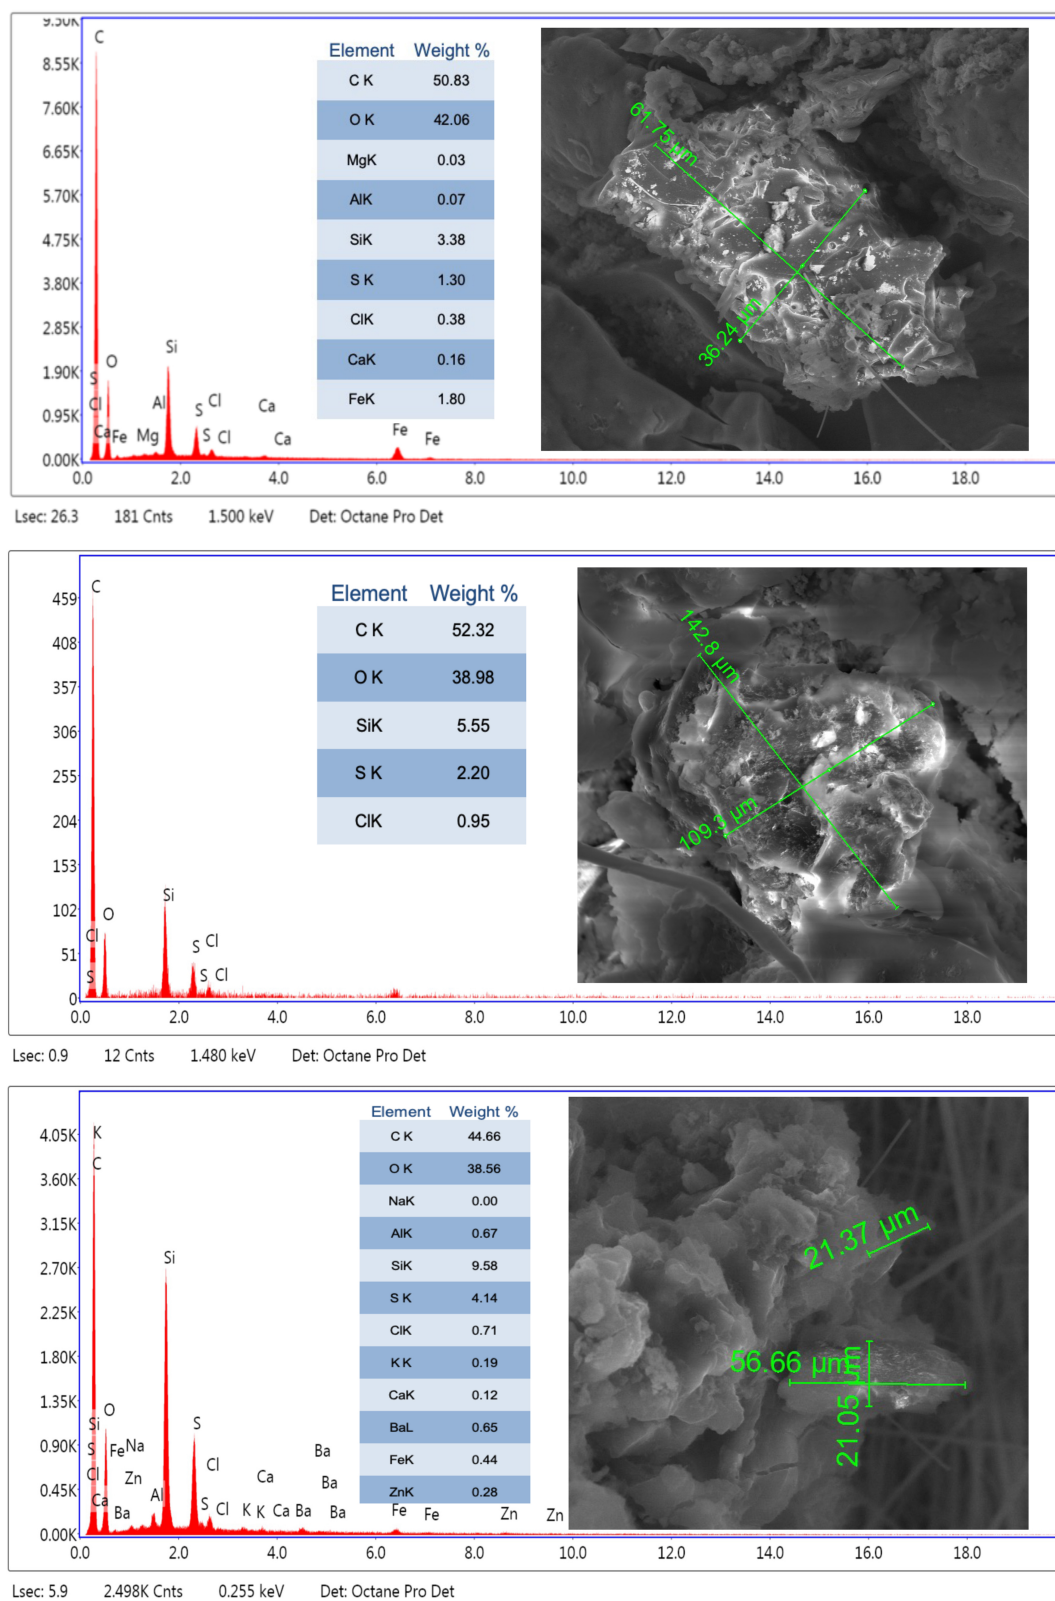
Figure 2. Elemental composition of selected MP particles. MP: Microplastic.

The origin and estimated residence time of MPs in the distribution network were determined using EDS spectra [Figure 2] and Raman spectra [Figure 3]. Elemental EDS analysis conducted for numerous MP fragments showed that they varied in carbon, chlorine, and oxygen content, indicating their different

residence times in the water supply network^[40] [Figure 2]. The results of the EDS analysis also showed that the MPs accumulated in the sediments originated mainly from plastics consisting of carbon, oxygen, and hydrogen [e.g., polyethylene (PE)/polypropylene (PP), polyethylene terephthalate (PET)], while polymers containing nitrogen in the structure (e.g., polyamides, polyimides, nylon or polyureas) were a less abundant fraction. No fragments of plastics containing high levels of chlorine [e.g., polyvinyl chloride (PVC)] were found. Raman spectroscopy technique was used to identify the isolated particles. The spectra were interpreted on the basis of analysis of the bands constituting “finger prints” of individual polymers^[31,32,34] and by comparison with spectra of reference materials. This allowed confirmation of the origin of the isolated particles from PE and PET, and less frequently, from polyamides [Figure 3]. However, with the technique

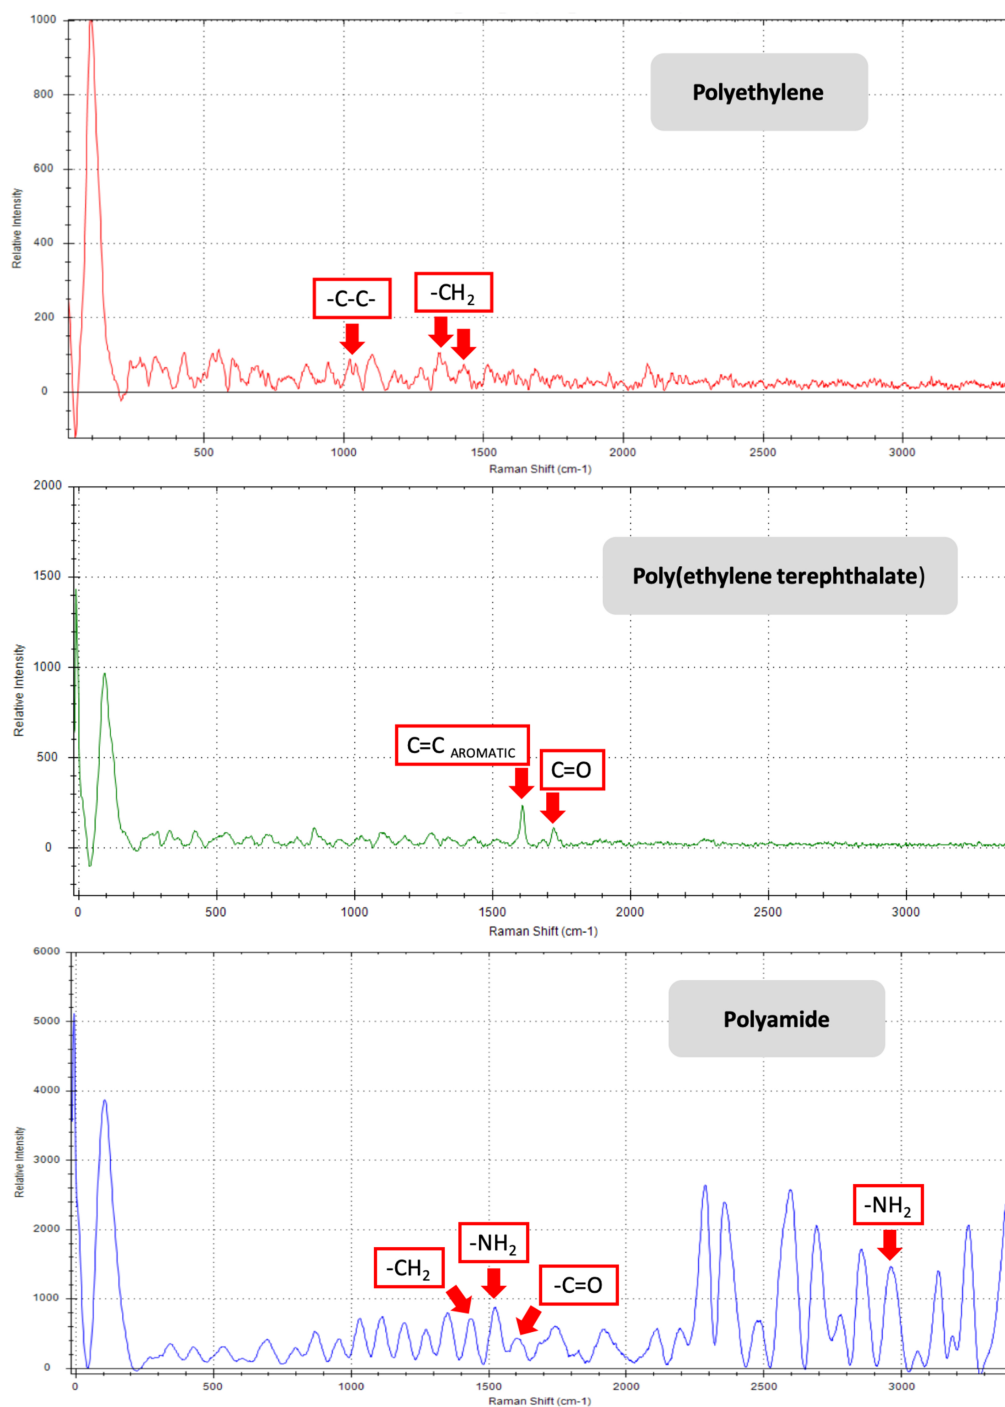
Figure 3. Raman spectra of identified MP particles showing characteristic “finger print” bands. MP: Microplastic.
